# PRODUCT UPDATE

Number 2  
Revision 1

## ACE BAC-7 MECHANICAL SEALS

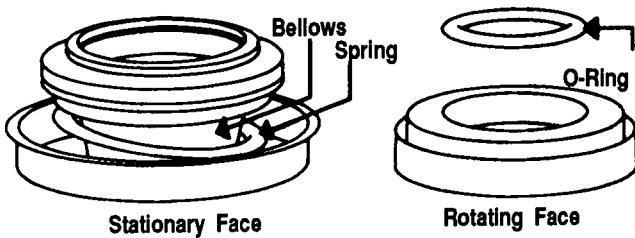
ACE BAC-7 mechanical seals consist of two basic parts: a spring-loaded stationary face that is pressed into the pump frame, and a rotating face that goes behind the impeller.
