# **Centrifugal Pump Warranty Guide**

The purpose of this guide is to help identify pump problems, their cause, and suggest ways to prevent recurrence. Ace Pump Corporation is an ISO 9001:2000 certified company which strives to maintain the highest level of product quality and reliability. All pump assemblies are tested prior to shipment.

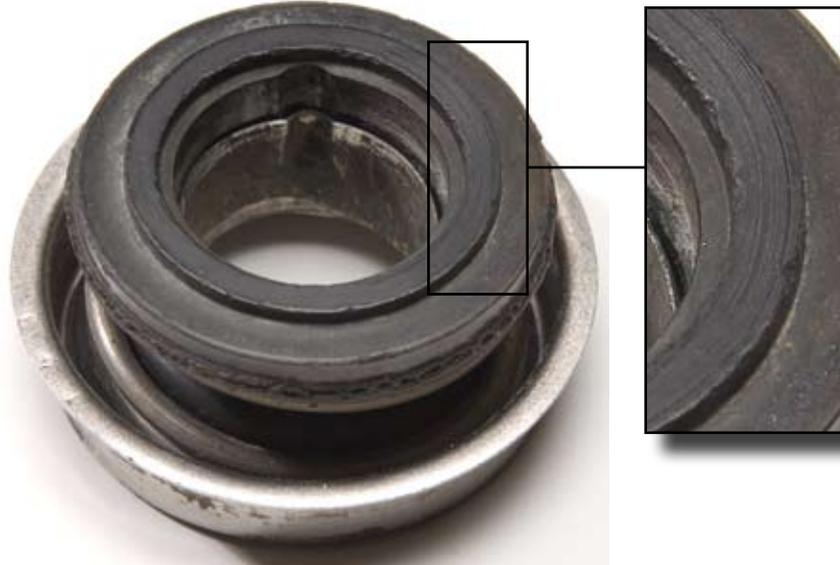
### Abrasive Shaft Seal Failure

Abrasive wear is the most common cause of seal leaks. It is caused by small particles in the solution passing between the seal faces and scratching the surface.

Abrasive wear is evident by grooving or scratching of the seal faces (most commonly the black carbon face). The seal surface must have a polished reflective surface to seal properly.

**Prevention:** Abrasive wear can be avoided by flushing the pump with clean water after each use. An optional silicon carbide shaft seal is also available for most pump models. The silicon carbide seal faces are much harder than the carbon and resist scratching. Granular chemical formulations should be added slowly so they will mix and dissolve before passing through the pump.

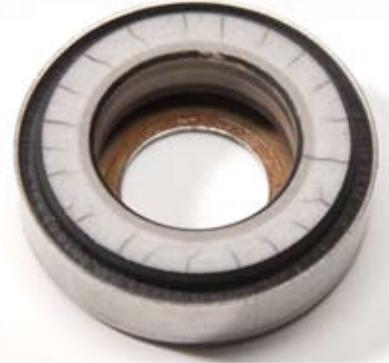
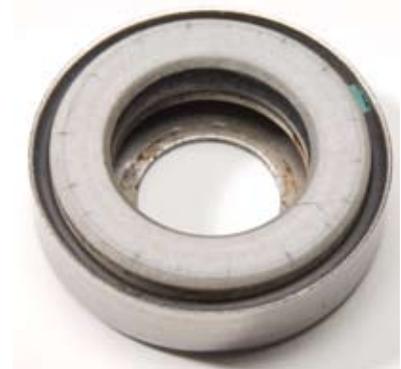
### Run Dry Seal Failure

This occurs when the pump is operated without enough liquid to lubricate and cool the seal faces.

In the standard seal, the ceramic face experiences thermal shock when cool liquid contacts the hot face causing cracks.

**Prevention:** These failures can be avoided by mounting the pump low on equipment to ensure a flooded suction, venting trapped air from the pump, and not emptying the spray tanks completely.

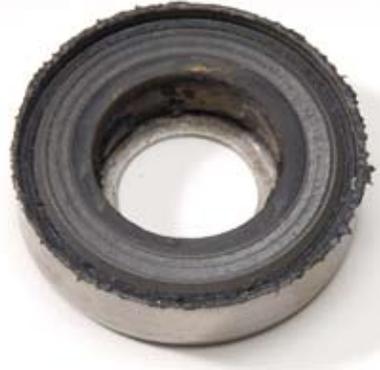
The silicon carbide material is harder and generates heat more quickly. It is resistant to thermal shock. Instead, the Viton<sup>®</sup> cup around the seal face melts resulting in leakage.

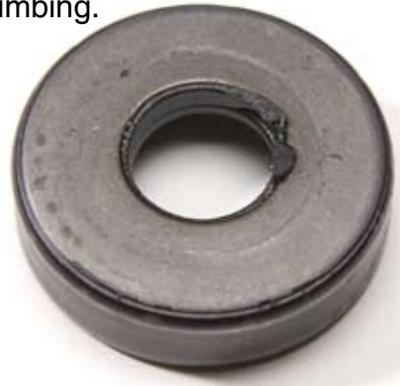
#### 1) High Back Pressure in the Return Line

This is the most common cause of shortened motor seal life. The hydraulic motor seal is rated for 250 psi of back pressure. However, a continuous return pressure of 100 psi or less is recommended for efficient operation and optimum seal life. The high return pressure is caused by restrictions in hoses, fittings, and tractor plumbing.

Seal lips pressed tight against the outer seal housing and shaft. There may also be grooves in the shaft where the seal lips touch.

**Prevention:** The best way to minimize return pressure is to return oil directly back to the tractor reservoir. Most tractor manufacturers now offer a Low Pressure Return Port option for this purpose. Contact your dealer for the specific options available for your tractor model. Proper hydraulic hose sizing is also important to minimize restriction. An open hose coupling may also be used to reduce restrictions in the return line. Ace recommends 1/2" hose for 200 Series motors and 3/4" hose for 300 series motors. The hoses should be sized larger if individual lengths exceed 15 feet.

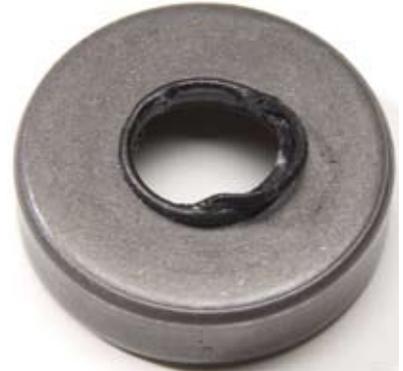
### 2) Pressure Spike

System pressure spikes may also damage the shaft seal and cause leakage. Spikes in the 3000-5000 psi range may result from improperly synchronized hydraulic valves or quick couplers coming unplugged during operation.

The seal lips are pressed tight against the outer seal housing and form a right angle between the seal housing and the shaft. In severe cases, the seal lip material may be extruded between the front seal casing and the shaft.

**Prevention:** Using a Low Pressure Return Port prevents spikes by keeping the return line open back to the reservoir at all times. If not using a low pressure return, the pump should always be turned off by moving the lever to the Float position. When moved to Float, the oil supply valve is shut but the return valve stays open.

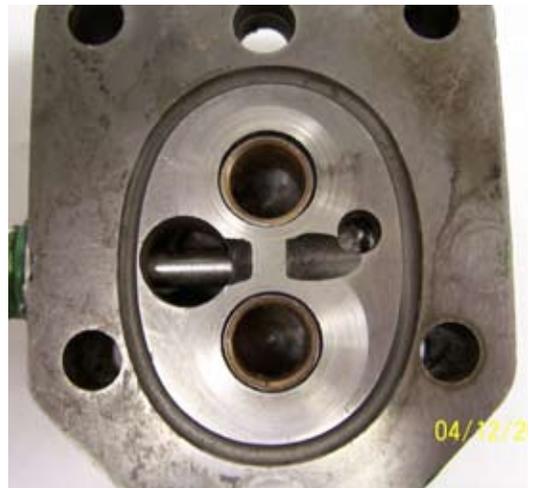
### Excess Hydraulic Flow

Ace hydraulic motors are high efficiency gear type motors designed to operate in a specific range of oil flows. Failure will result if the rated flow of a motor is exceeded during operation. The damage may vary depending on the length of operation and amount of oil flow. Damage can range from reduced performance and efficiency to motor seizure.

Scoring on the end and drive plates in the gear path indicates the gears have expanded due to excessive heat. Heat discoloration of the motor shaft in the seal area also indicates the motor has been running at higher rpm than rated.

**Prevention:** Determining the tractor's hydraulic system type and following the proper setup procedures is the best way to avoid this failure. Consult our [Tractor Hydraulic System Selection Guide \(HSG\)](#) printed or online at [www.AcePumps.com](http://www.AcePumps.com) for specific tractor information and setup procedures.

The Flow Limiter is recommended for use with pumps mounted on tractors with Load Sensing Hydraulic Systems. The flow limiter stops the flow of oil to the hydraulic motor if the motors rated flow is exceeded. This valve reminds the operator that the flow must be adjusted each time the sprayer is connected. Please consult Ace Form [FLOW LIMITER](#) for available sizes and installation instructions.

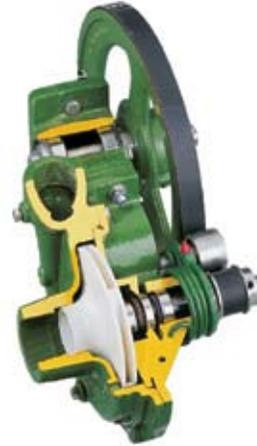
### Belt Comes Off

The belt coming off is typically an indication that the pulley alignment has shifted or the idler arm movement is restricted. The alignment of new pumps may be affected by rough handling in shipment.

Rotate the large pulley back and forth while watching the belt tracking on the idler roller. If the belt shifts on the roller when you change directions, the pulleys need alignment. See alignment procedure in box below. Check the idler arm for rust or restricted movement.

**Prevention:** Check alignment periodically as detailed above. Grease the idler arm once a week during spraying season and prior to winter storage.

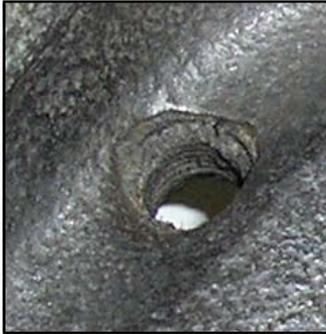
### Casting Erosion

This occurs when the pumped chemical attacks the cast iron housing. The cast material is removed from the inside surfaces of the pump resulting in thin spots and leaks. The first external sign is typically a leak at one of the pipe plugs.

**Prevention:** If the failure occurs in a short period of time, there is a chemical compatibility issue with cast iron. Other pump materials such as e-coated cast iron or stainless steel should be considered. Call for availability and additional information.

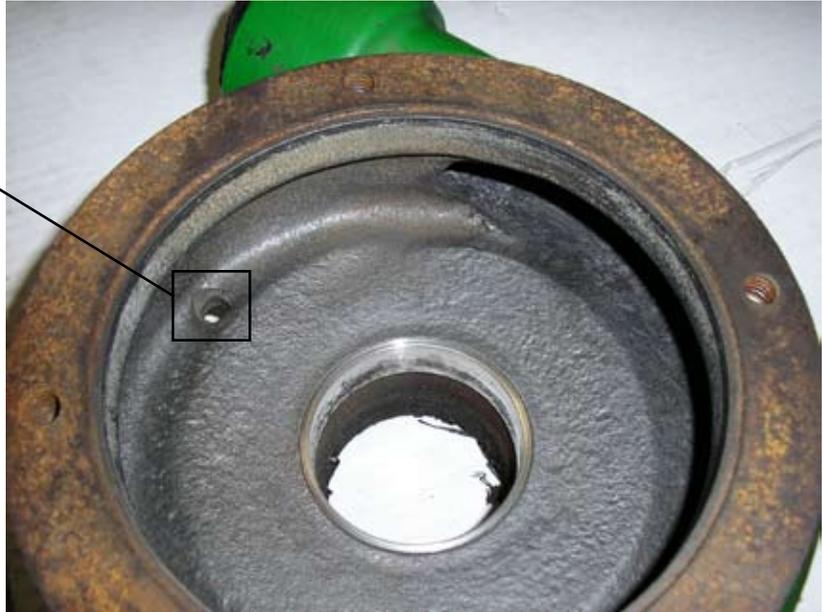
A dull gray color on the inside of the pump casing with wear particularly inside the volute face and water channel.
